**Flood Control Project Maintenance  
Levee Inspections****LMA District Cover Sheet****Spring 2016 Levee Inspection Results****Reclamation District No. 0150 Merrit Island**

**Spring 2016 Levee Inspection Results**

**Reclamation District No. 0150 Merrit Island**

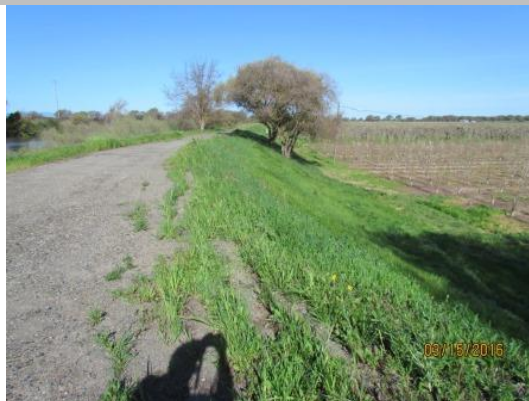
Photo 1 of 1 : SP\_2016\_RD0150\_15\_7\_20160318\_00005.jpg

LM Start	0.03	Rating **	M	Issue No.	7
LM End	0.50	Issue Type +	Ma	Location *	LS
Category	Earthen Levee			GPS Latitude/Longitude	
				Start	End
Item	Vegetation			38.332483 °	38.328172 °
				-121.583042 °	-121.576431 °
DWR ID	DWR_RD0150_01_s_2016_7				
Comment Code					
V1 : Control annual grass and weeds on the levee slopes and easements.					
Inspector Comment

View of the vegetation on the landside slope of the levee.

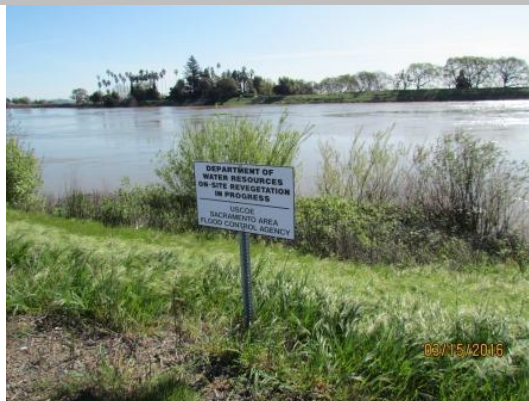
Photo 1 of 1 : SP\_2016\_RD0150\_16\_5\_20160318\_00113.jpg

LM Start	0.14	Rating **	A/W	Issue No.	5
LM End	4.77	Issue Type +	En	Location *	WS
Category	Earthen Levee			GPS Latitude/Longitude	
				Start	End
Item	Vegetation			38.329782 °	38.374641 °
				-121.574769 °	-121.524730 °
DWR ID	DWR_RD0150_02_s_2012_5				
Comment Code					
V8 : Environmental Requirements.					
Inspector Comment

View of the re-vegetation sign.

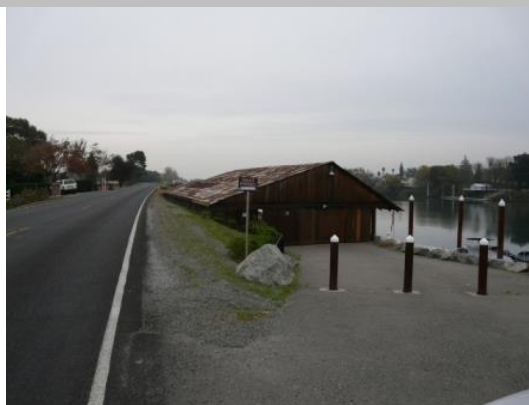
Photo 1 of 1 : SP\_2016\_RD0150\_16\_49\_20160219\_00026.jpg

LM Start	0.16	Rating **	U	Issue No.	49
LM End	0.16	Issue Type +	En	Location *	WS
Category	Earthen Levee			GPS Latitude/Longitude	
				Start	End
Item	Encroachments			38.330047 °	38.330047 °
				-121.574538 °	-121.574538 °
DWR ID	DWR_RD0150_02_s_2012_49				
Comment Code					
BU : Building					
Inspector Comment

Building located on waterside of levee at LM 0.16

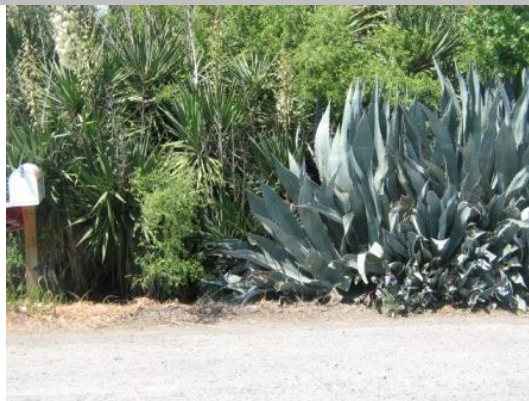
Photo 1 of 1 : SP\_2016\_RD0150\_16\_4\_20160219\_00001.jpg

LM Start	0.25	Rating **	U	Issue No.	4
LM End	0.25	Issue Type +	En	Location *	LS
Category	Earthen Levee			GPS Latitude/Longitude	
				Start	End
Item	Vegetation			38.331035 °	38.331035 °
				-121.573502 °	-121.573502 °
DWR ID	DWR_RD0150_02_s_2012_4				
Comment Code					
V6 : Landscaping					
Inspector Comment

Landscaping on landward slope of the levee.

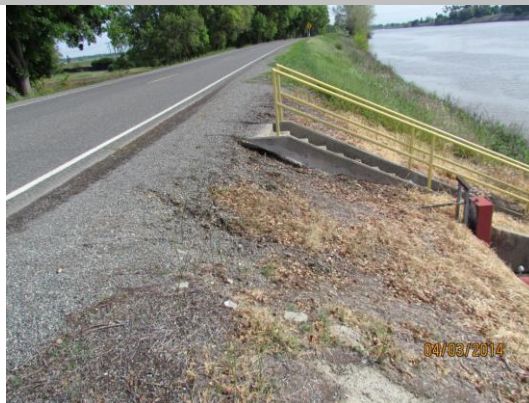
Photo 1 of 2 : SP\_2016\_RD0150\_16\_6\_20160219\_00002.jpg

LM Start	0.39	Rating **	M	Issue No.	6
LM End	0.39	Issue Type +	Ma	Location *	WS
Category	Earthen Levee			GPS Latitude/Longitude	
				Start	End
Item	Slope Stability			38.332717 °	38.332717 °
				-121.572083 °	-121.572083 °
DWR ID	DWR_RD0150_02_s_2012_6				
Comment Code					
S2 : Repair the levee slope damaged by foot traffic and prevent access where possible.					
Inspector Comment

Updated photo of the slope instability on the waterside of the levee looking upstream during spring 2014 inspection.

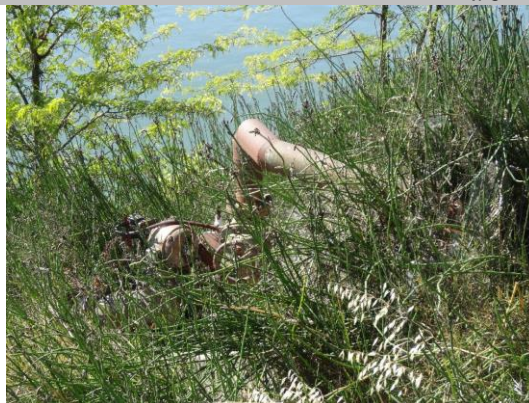
Photo 1 of 2 : UCIP\_SP\_2016\_20267\_34239.jpg

LM Start	0.46	Rating **	M	Issue No.	1002
LM End	0.46	Issue Type +	En	Location *	WS
Category	Supplemental			GPS Latitude/Longitude	
				Start	End
Item	DWR UCIP Field Study			38.333527 °	38.333527 °
				-121.571274 °	-121.571274 °
DWR ID					
Comment Code					
Inspector Comment					
FS_ID:20267					
DS_ID:22418					
EP_NO: N/A					
Repair Type: Non-Urgent					
Crossing Status: Found					
UCIP Comments: - Abandoned pipe and pump.- Needs proper abandonment.					
FIELD_STRUCT_DESC: 6-inch steel pipe and 1-inch conduit through the levee, 3.5 feet below crown, pump and gate valve on the waterward slope. Electric box on waterside slope. O&M Manual SAC 112, March 1957.					
FS Date: 8/27/2013

WS view: steel pipe and pump on levee slope. Dense vegetation on waterside.

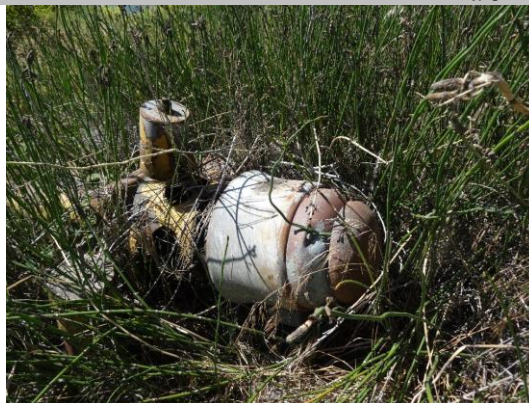
Photo 1 of 2 : UCIP\_SP\_2016\_20284\_34265.jpg

FS\_ID:20284  
DS\_ID:22419  
EP\_NO: N/A  
Repair Type: Non-Urgent  
Crossing Status: Found  
UCIP Comments: Needs proper abandonment.  
FIELD\_STRUCT\_DESC: 8-inch steel pipe through the levee, 5.7 feet below the crown. Power line on landside.(Mrs. J. Olson) O&M Manual SAC 112, March 1957.  
FS Date: 8/27/2013

WS view: abandoned pump on levee slope. Dense vegetation on waterside.

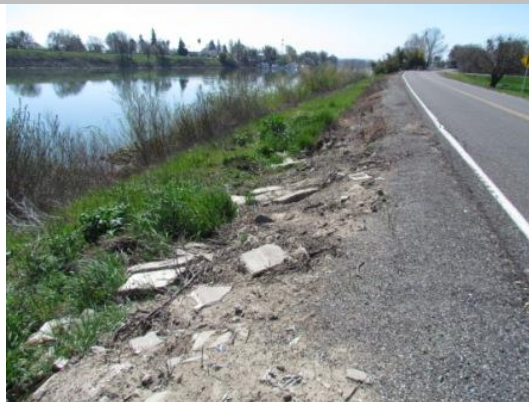
Photo 1 of 1 : SP\_2016\_RD0150\_16\_10\_20160219\_00006.jpg

LM Start	0.71	Rating **	M	Issue No.	10
LM End	0.71	Issue Type +	Ma	Location *	WS
Category	Earthen Levee			GPS Latitude/Longitude	
				Start	End
Item	Encroachments			38.336228 °	38.336228 °
				-121.568332 °	-121.568332 °
DWR ID	DWR_RD0150_02_s_2013_10				
Comment Code					
DE : Debris					
Inspector Comment

Debris was found on the waterside slope of the levee looking downstream during Spring 2013 inspection.

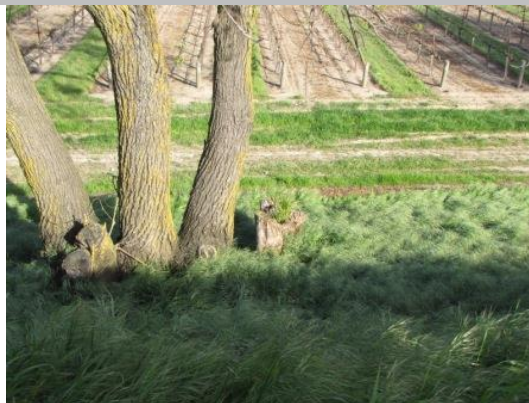
Photo 1 of 1 : SP\_2016\_RD0150\_16\_8\_20160219\_00004.jpg

LM Start	1.14	Rating **	N	Issue No.	8
LM End	1.14	Issue Type +	Ma	Location *	LS
Category	Earthen Levee			GPS Latitude/Longitude	
				Start	End
Item	Trim / Thin Trees			38.340864 °	38.340864 °
				-121.562915 °	-121.562915 °
DWR ID	DWR_RD0150_02_s_2012_8				
Comment Code					
T5 : Tree stumps.					
Inspector Comment

View of a tree stump on the landward slope.

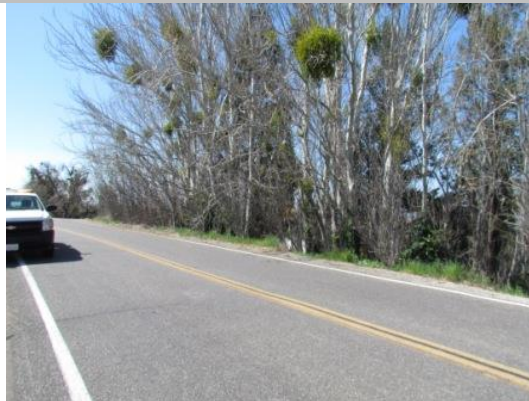
Photo 1 of 2 : SP\_2016\_RD0150\_16\_91\_20160219\_00044.jpg

LM Start	1.32	Rating **	U	Issue No.	91
LM End	1.34	Issue Type +	En	Location *	LS
Category	Earthen Levee			GPS Latitude/Longitude	
				Start	End
Item	Vegetation			38.342969 °	38.343252 °
				-121.561196 °	-121.560794 °
DWR ID	DWR_RD0150_02_s_2012_91				
Comment Code					
V6 : Landscaping					
Inspector Comment

Landscaping was obstructing the view of the landside slope of the levee looking downstream. This picture was taken during spring 2013 inspection.

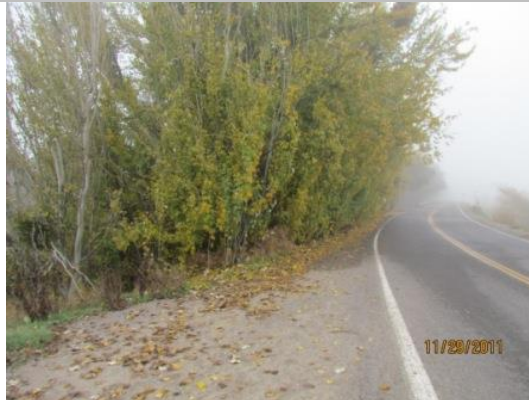
Photo 2 of 2 : SP\_2016\_RD0150\_16\_91\_20160219\_00045.jpg

Landscaping was found landside of the levee looking upstream.

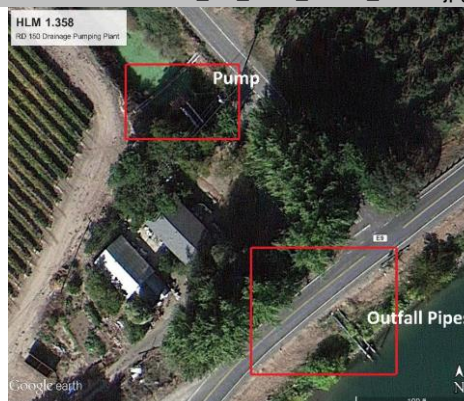
Photo 1 of 2 : UCIP\_SP\_2016\_20727\_34889.jpg

FS\_ID:20727  
DS\_ID:22393  
EP\_NO: 18221  
Repair Type: Non-Urgent  
Crossing Status: Found  
UCIP Comments: Pump house and drainage ditch about 250 feet from the levee on landside. Pumps on piling structure with shed in drainage ditch. Siphon breaker cover missing. Needs to fix it.  
FIELD\_STRUCT\_DESC: 1 of 2: 30-inch pipe (of 30-inch and 24-inch steel pipes), 7.0 feet below the crown replaced 36-inch and 24-inch pipes through the levee, 9.0 and 8.0 feet below the crown respectively. Flap gates on the waterward ends. Siphon breakers on the waterward slope. Pumps on piling structure with shed in drainage ditch. (App. No. 18221 - R.D. No. 150 drainage plant). O&M Manual SAC 112, March 1957.  
FS Date: 8/27/2013

Bird's eye view: outfall pipes (bottom) and pump structure in drainage ditch (top)

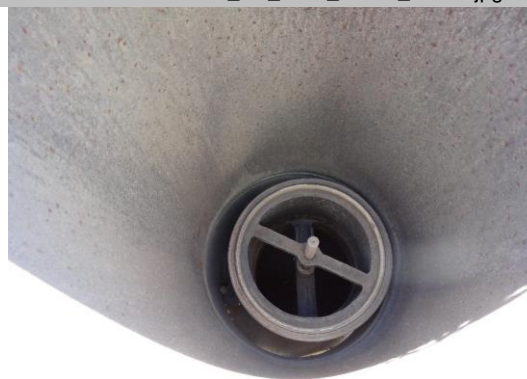
Photo 2 of 2 : UCIP\_SP\_2016\_20727\_34888.jpg

WS view: siphon breaker in pipe riser on levee shoulder.

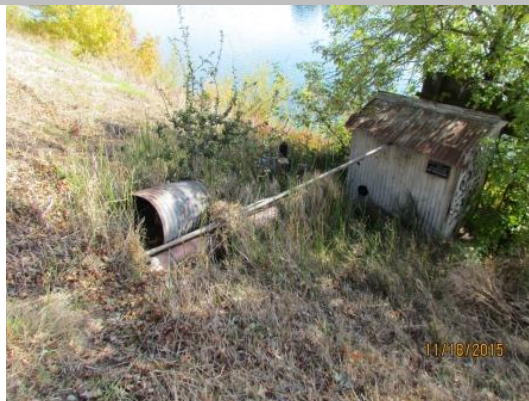
Photo 1 of 1 : SP\_2016\_RD0150\_16\_53\_20160219\_00028.jpg

LM Start	1.56	Rating **	M	Issue No.	53
LM End	1.56	Issue Type +	Ma	Location *	WS
Category	Earthen Levee			GPS Latitude/Longitude	
				Start	End
Item	Encroachments			38.344881 °	38.344881 °
				-121.557524 °	-121.557524 °
DWR ID	DWR_RD0150_02_f_2015_53				
Comment Code					
PI : Pipe					
Inspector Comment					
Abandoned pipes were found on the waterside slope.

Abandon pipes and debris was found on the waterside of the levee.

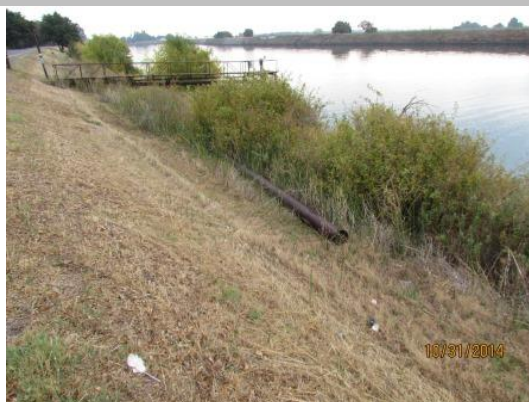
Photo 1 of 1 : SP\_2016\_RD0150\_16\_50\_20160219\_00027.jpg

LM Start	1.89	Rating **	M	Issue No.	50
LM End	1.89	Issue Type +	Ma	Location *	WS
Category	Earthen Levee			GPS Latitude/Longitude	
				Start	End
Item	Encroachments			38.346323 °	38.346323 °
				-121.551568 °	-121.551568 °
DWR ID	DWR_RD0150_02_f_2014_50				
Comment Code					
PI : Pipe					
Inspector Comment					
An abandoned pipe was found on the waterside of the levee.

A pipe was found on the waterside toe of the levee looking upstream.

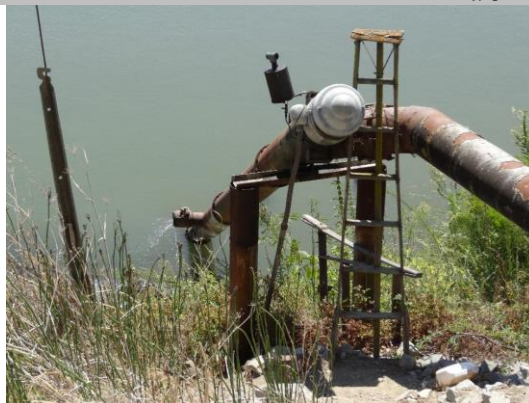
Photo 1 of 2 : UCIP\_SP\_2016\_20731\_34902.jpg

WS view: slant pump on steel frame support and exposed pipe on levee slope.

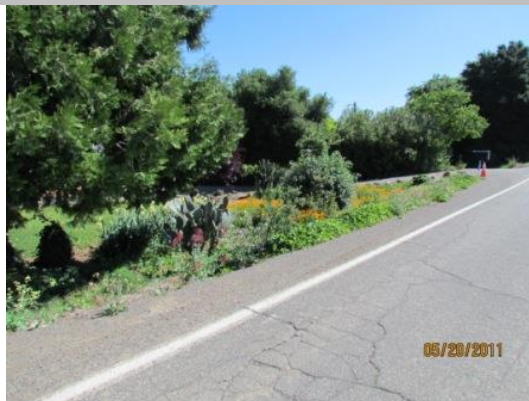
Photo 1 of 1 : SP\_2016\_RD0150\_16\_88\_20160219\_00043.jpg

LM Start	2.28	Rating **	M	Issue No.	88
LM End	2.30	Issue Type +	En	Location *	LS
Category	Earthen Levee			GPS Latitude/Longitude	
				Start	End
Item	Vegetation			38.347355 °	38.347361 °
				-121.544628 °	-121.544280 °
DWR ID	DWR_RD0150_02_s _ 2012_88				
Comment Code					
V6 : Landscaping					
Inspector Comment

Landscaping was found on the landside of the levee. The picture was taken from the crown looking upstream.

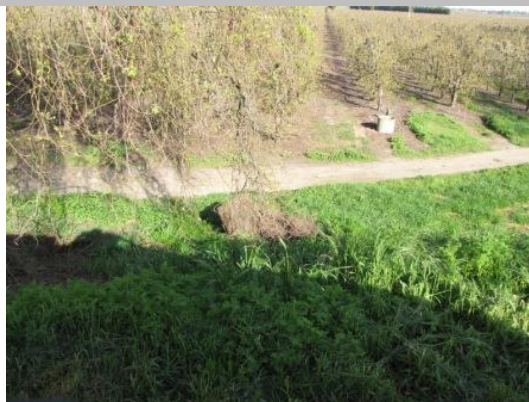
Photo 1 of 1 : SP\_2016\_RD0150\_16\_14\_20160219\_00009.jpg

LM Start	2.75	Rating **	N	Issue No.	14
LM End	2.75	Issue Type +	Ma	Location *	LS
Category	Earthen Levee			GPS Latitude/Longitude	
				Start	End
Item	Trim / Thin Trees			38.350041 °	38.350041 °
				-121.536853 °	-121.536853 °
DWR ID	DWR_RD0150_02_s _ 2012_14				
Comment Code					
T5 : Tree stumps.					
Inspector Comment

View of a tree stump on the landward slope.

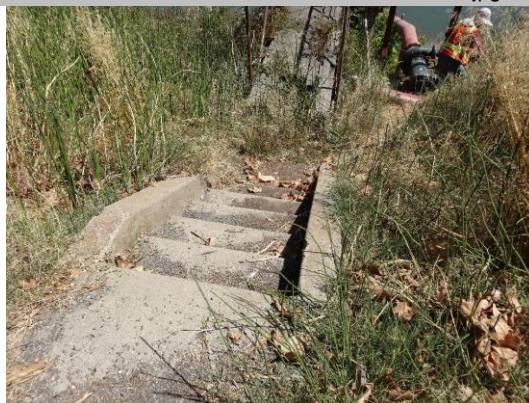
Photo 1 of 2 : UCIP\_SP\_2016\_20732\_34906.jpg

WS view: walkway steps, pipe, and pump on levee slope.

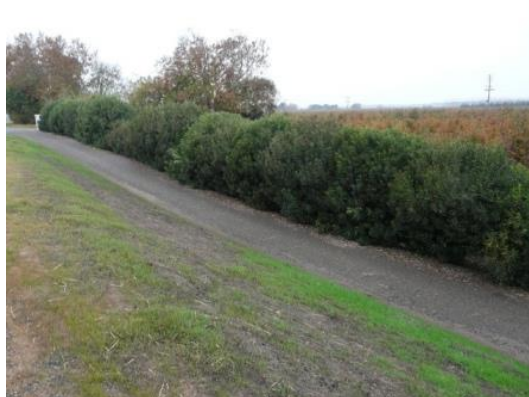
Photo 1 of 1 : SP\_2016\_RD0150\_16\_85\_20160219\_00042.jpg

LM Start	2.97	Rating **	U	Issue No.	85
LM End	3.01	Issue Type +	En	Location *	LS
Category	Earthen Levee			GPS Latitude/Longitude	
				Start	End
Item	Vegetation			38.352372 °	38.352802 °
				-121.534127 °	-121.533638 °
DWR ID	DWR_RD0150_02_s _ 2012_85				
Comment Code					
V6 : Landscaping					
Inspector Comment

Landscaping providing a screen for a residence on the landside of levee.

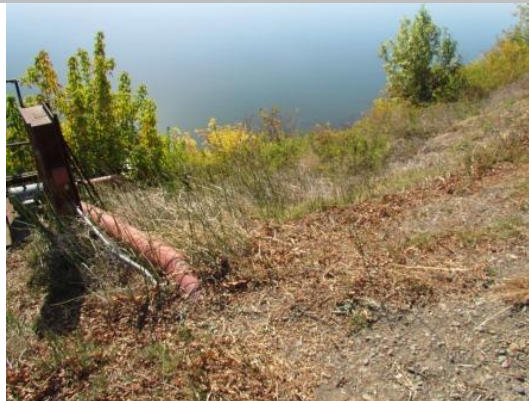
Photo 2 of 5 : SP\_2016\_RD0150\_16\_961\_20160219\_00048.jpg

LM Start	3.24	Rating **	M	Issue No.	961
LM End	3.24	Issue Type +	Ma	Location *	WS
Category	Earthen Levee			GPS Latitude/Longitude	
				Start	End
Item	Erosion / Bank Caving			38.355321 °	38.355321 °
				-121.530902 °	-121.530902 °
DWR ID	DWR_RD0150_02_s _ 2012_961				
Comment Code					
E2 : Schedule repair of erosion site prior to the next inspection.					
Inspector Comment					
Depressions into the waterward slope can be seen along the waterward slope at this site. Also note the damaged pump support, pump, and pipe just upstream of the site; they may contribute to the erosion in a high water event and should be removed.

View of the erosion on the waterside slope of the levee near the pipe looking downstream. This picture was taken during the fall 2013 inspection.

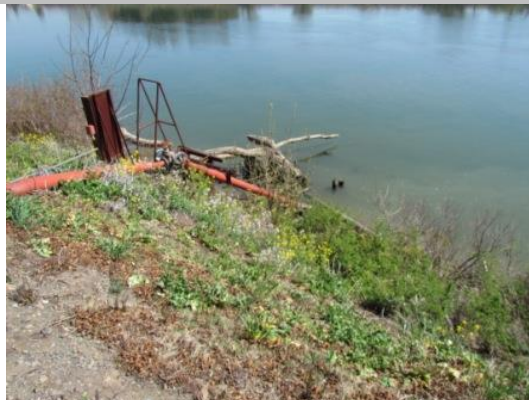
Photo 3 of 5 : SP\_2016\_RD0150\_16\_961\_20160219\_00049.jpg

View of the erosion on the waterside slope of the levee looking upstream during spring 2013 inspection.

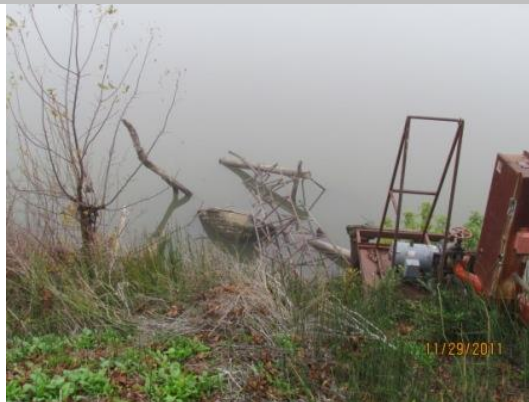
Photo 5 of 5 : SP\_2016\_RD0150\_16\_961\_20160219\_00051.jpg

View of the erosion site, and broken pump support along with a boat on the waterside of the levee. The picture was taken from the crown looking towards the toe of the levee during fall 2011 inspection.

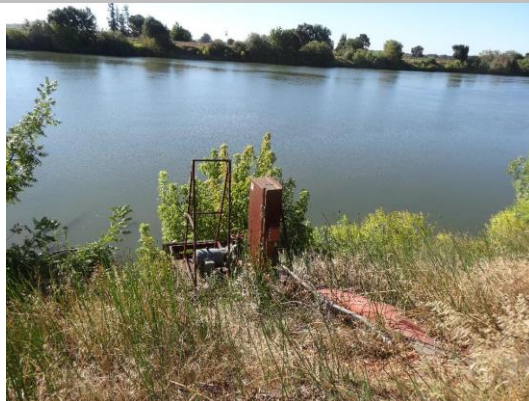
Photo 1 of 2 : UCIP\_SP\_2016\_20736\_34917.jpg

WS view: pipe, conduit and pump on levee slope.

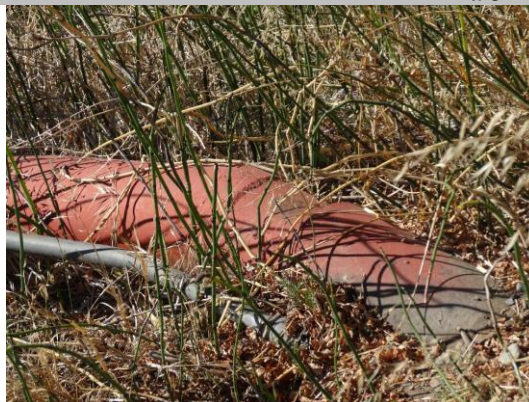
Photo 2 of 2 : UCIP\_SP\_2016\_20736\_34916.jpg

WS view: steel pipe and GI conduit on levee slope.

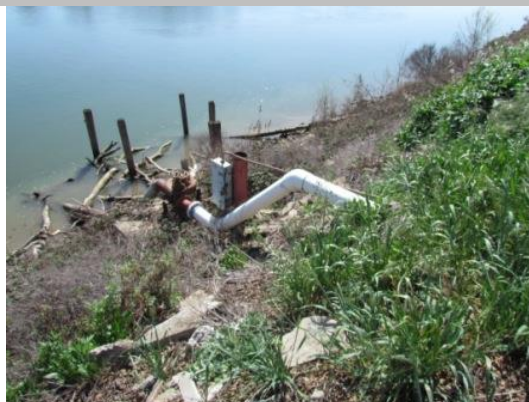
Photo 1 of 2 : SP\_2016\_RD0150\_16\_15\_20160219\_00010.jpg

LM Start	3.51	Rating **	M	Issue No.	15
LM End	3.51	Issue Type +	En	Location *	CR
Category	Earthen Levee			GPS Latitude/Longitude	
				Start	End
Item	Encroachments			38.358152 °	38.358152 °
				-121.527579 °	-121.527579 °
DWR ID	DWR_RD0150_02_s_2012_15				
Comment Code					
PI : Pipe					
Inspector Comment					
PVC pipe is sleeving through an old steel pipe. The steel pipe appears to be fine for now, but we should keep an eye on it.

A PVC pipe was used to pump the water from waterside of the levee. It appeared that the PVC pipe was penetrating through a corroded steel casing through the levee crown. The picture was taken from the crown of the levee looking upstream during spring 2013 inspection.

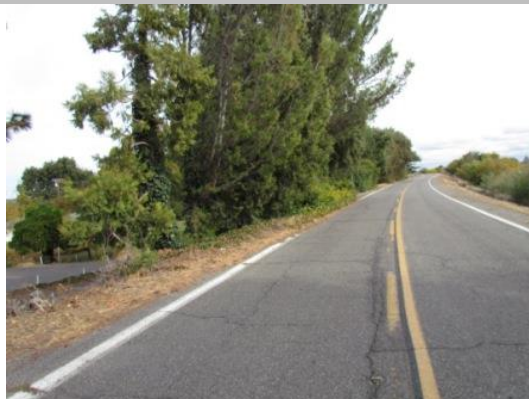
Photo 1 of 1 : SP\_2016\_RD0150\_16\_82\_20160219\_00041.jpg

LM Start	3.54	Rating **	U	Issue No.	82
LM End	3.67	Issue Type +	En	Location *	LS
Category	Earthen Levee			GPS Latitude/Longitude	
				Start	End
Item	Vegetation			38.358565 °	38.359729 °
				-121.527153 °	-121.525345 °
DWR ID	DWR_RD0150_02_s_2012_82				
Comment Code					
V6 : Landscaping					
Inspector Comment

Landscaping was blocking the visibility on the landside of the levee looking upstream.

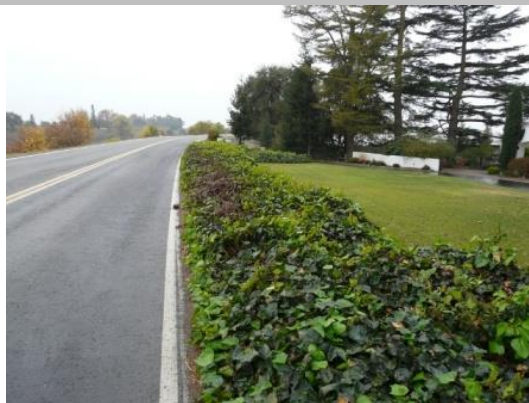
Photo 1 of 1 : SP\_2016\_RD0150\_16\_80\_20160219\_00040.jpg

LM Start	3.84	Rating **	U	Issue No.	80
LM End	3.86	Issue Type +	En	Location *	LS
Category	Earthen Levee			GPS Latitude/Longitude	
				Start	End
Item	Vegetation			38.361419 °	38.361752 °
				-121.523225 °	-121.522974 °
DWR ID	DWR_RD0150_02_s _ 2012_80				
Comment Code					
V6 : Landscaping					
Inspector Comment

Landscaping in front of a residence on landside of levee from LM 3.90 to LM 3.93. The levee in this location is greater than 100' wide.

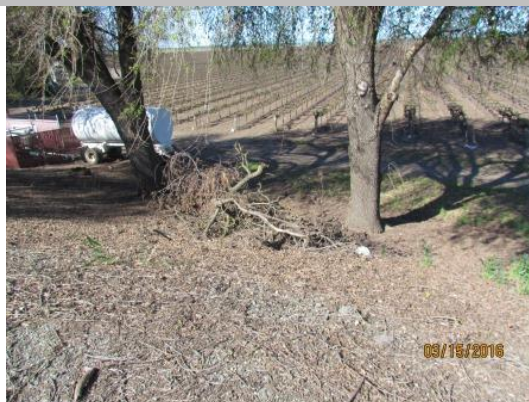
Photo 1 of 1 : SP\_2016\_RD0150\_16\_61\_20160318\_00116.jpg

LM Start	3.91	Rating **	M	Issue No.	61
LM End	3.91	Issue Type +	Ma	Location *	LS
Category	Earthen Levee			GPS Latitude/Longitude	
				Start	End
Item	Encroachments			38.362357 °	38.362357 °
				-121.522582 °	-121.522582 °
DWR ID	DWR_RD0150_02_s _ 2016_61				
Comment Code					
PR : Prunings					
Inspector Comment

View of prunings on the landside of the levee.

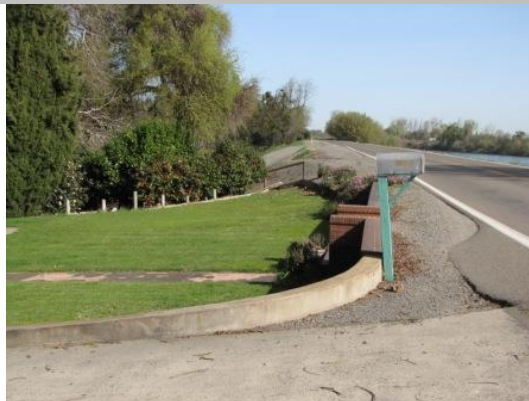
Photo 1 of 1 : SP\_2016\_RD0150\_16\_20\_20160219\_00012.jpg

LM Start	4.08	Rating **	M	Issue No.	20
LM End	4.10	Issue Type +	En	Location *	LS
Category	Earthen Levee			GPS Latitude/Longitude	
				Start	End
Item	Encroachments			38.364854 °	38.365104 °
				-121.522378 °	-121.522365 °
DWR ID	DWR_RD0150_02_s_2012_20				
Comment Code					
BU : Building					
Inspector Comment					
3' retaining wall at the landward shoulder.

View of a retaining wall on the landward slope looking upstream.

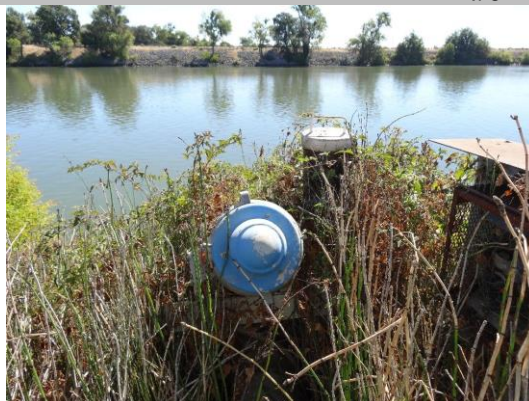
Photo 1 of 2 : UCIP\_SP\_2016\_42702\_33782.jpg

Comment Code					
Inspector Comment					
FS_ID:42702 DS_ID:22407 EP_NO: 13505 Repair Type: Non-Urgent Crossing Status: Found UCIP Comments: Appears abandoned and if so should be done so properly.- no pipe and structure found on landside.- siphon breaker in 24" CMP riser on waterside.- control box and electric conduit on waterside slope. FIELD_STRUCT_DESC: 14-inch steel pipe through the levee, 5.0 feet below the crown; slanted pump on the waterside slope. Siphon breaker in the waterside slope in corrugated metal pipe riser. A control box and electric conduit on waterside slope. (Permit No. 13505 - Clara Herringer). O&M Manual SAC 112, March 1957. FS Date: 8/30/2013

WS view: slanted pump on levee slope.

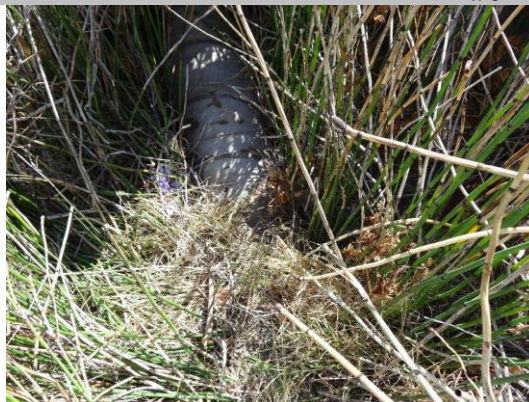
Photo 2 of 2 : UCIP\_SP\_2016\_42702\_33781.jpg

WS view: exposed 14-inch steel pipe on levee slope.

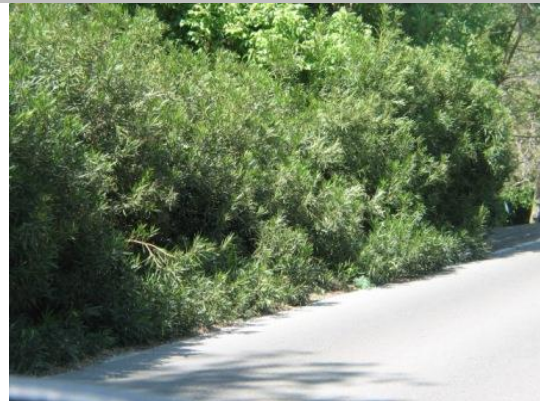
Photo 1 of 1 : SP\_2016\_RD0150\_16\_24\_20160219\_00014.jpg

LM Start	4.26	Rating **	U	Issue No.	24
LM End	4.28	Issue Type +	En	Location *	LS
Category	Earthen Levee			GPS Latitude/Longitude	
				Start	End
Item	Vegetation			38.367442 °	38.367740 °
				-121.522427 °	-121.522495 °
DWR ID	DWR_RD0150_02_s_2012_24				
Comment Code					
V6 : Landscaping					
Inspector Comment

Landscaping (Oleander) on landward slope from 4.33 to 4.35

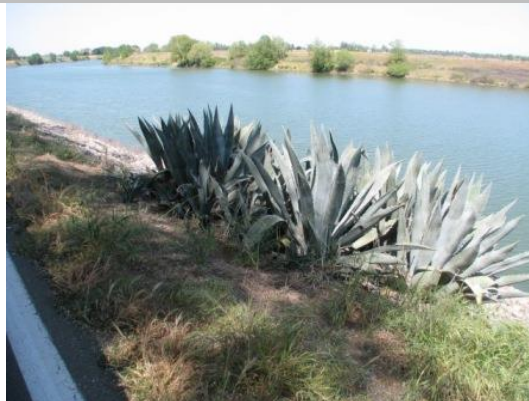
Photo 1 of 1 : SP\_2016\_RD0150\_16\_28\_20160219\_00016.jpg

LM Start	4.69	Rating **	M	Issue No.	28
LM End	4.69	Issue Type +	Ma	Location *	WS
Category	Earthen Levee			GPS Latitude/Longitude	
				Start	End
Item	Vegetation			38.373485 °	38.373485 °
				-121.523963 °	-121.523963 °
DWR ID	DWR_RD0150_02_s_2012_28				
Comment Code					
V2 : Remove the wild growth other than native grasses from the levee slopes.					
Inspector Comment

Century plant on waterward slope at LM 4.76

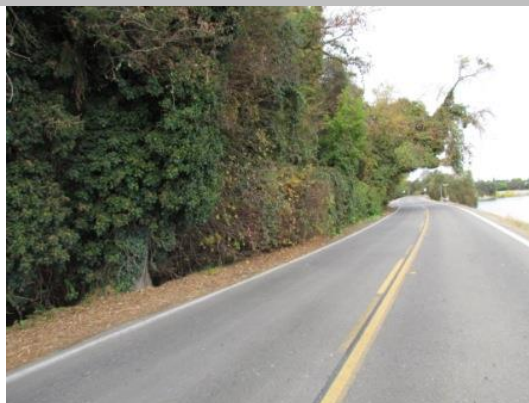
Photo 1 of 1 : SP\_2016\_RD0150\_16\_76\_20160219\_00038.jpg

LM Start	4.70	Rating **	U	Issue No.	76
LM End	4.72	Issue Type +	En	Location *	LS
Category	Earthen Levee			GPS Latitude/Longitude	
				Start	End
Item	Vegetation			38.373688 °	38.373970 °
				-121.524280 °	-121.524403 °
DWR ID	DWR_RD0150_02_s_2012_76				
Comment Code					
V6 : Landscaping					
Inspector Comment

Trees were obstructing the view of the landside slope of the levee looking upstream.

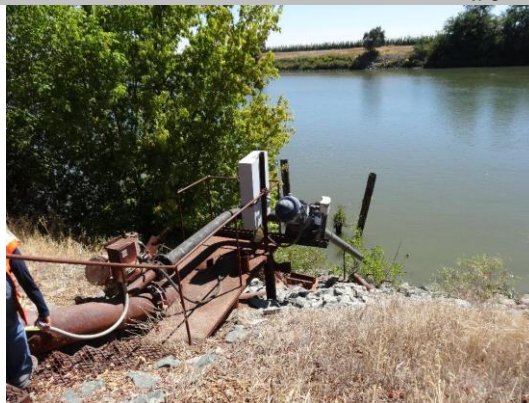
Photo 1 of 2 : UCIP\_SP\_2016\_20740\_34941.jpg

LM Start	5.24	Rating **	M	Issue No.	991
LM End	5.24	Issue Type +	En	Location *	LS
Category	Supplemental			GPS Latitude/Longitude	
				Start	End
Item	DWR UCIP Field Study			38.381079 °	38.381079 °
				-121.524166 °	-121.524166 °
DWR ID					
Comment Code					
Inspector Comment					
FS_ID:20740 DS_ID:22410 EP_NO: N/A Repair Type: Non-Urgent Crossing Status: Found UCIP Comments: - 2" electric conduit and gate valve on WS.- abandoned old pump not removed from WS- working during field survey FIELD_STRUCT_DESC: 12-inch pipe and 2-inch electric conduit through the levee, 3.0 feet below the crown. Service pole and standpipe at the toe of the landward slope. (C. Sakai) O&M Manual SAC 112, March 1957. FS Date: 8/30/2013

WS view: pipe, walkway, slant pump &amp; pump platform on stream bank.

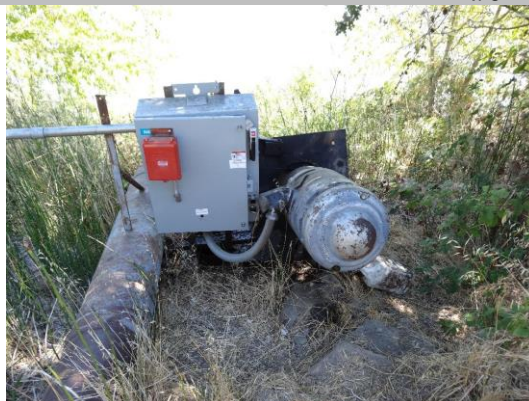
Photo 1 of 2 : UCIP\_SP\_2016\_20748\_34967.jpg

FS\_ID:20748  
DS\_ID:22412  
EP\_NO: N/A  
Repair Type: Non-Urgent  
Crossing Status: Found  
UCIP Comments: - slope erosion due leaky siphon breaker at CMP riser- leaky pipe and pump- service pole on LS- 2" electric conduit on WS  
FIELD\_STRUCT\_DESC: 10-inch steel pipe and an electric conduit through the levee, 4.8 feet below the crown. Slant pump on the waterward slope. Siphon breaker in corrugated metal pipe riser on the landward shoulder. Slope erosion on landside of levee at siphon breaker. (Ed. Boyles) O&M Manual SAC 112, March 1957.  
FS Date: 8/30/2013

WS view: steel pipe and slant pump on levee slope.

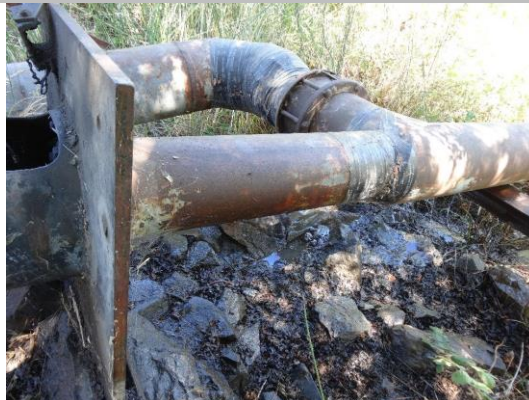
Photo 2 of 2 : UCIP\_SP\_2016\_20748\_34966.jpg

WS view: leaky steel pipe and slant pump on levee slope.

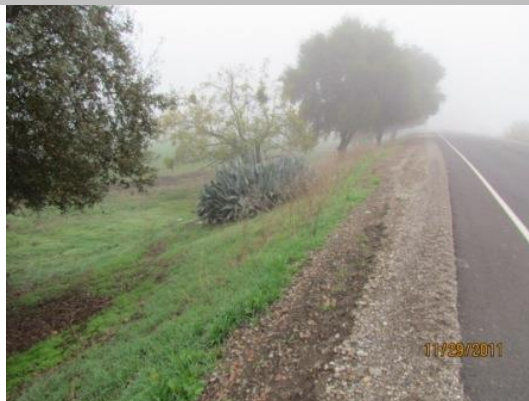
Photo 1 of 1 : SP\_2016\_RD0150\_16\_27\_20160219\_00015.jpg

LM Start	6.30	Rating **	M	Issue No.	27
LM End	6.30	Issue Type +	En	Location *	LS
Category	Earthen Levee			GPS Latitude/Longitude	
				Start	End
Item	Vegetation			38.393655 °	38.393655 °
				-121.514654 °	-121.514654 °
DWR ID	DWR_RD0150_02_s _ 2012_27				
Comment Code					
V6 : Landscaping					
Inspector Comment					
Century plant on the landward slope.

Century plant was found on the landside of the levee looking upstream.

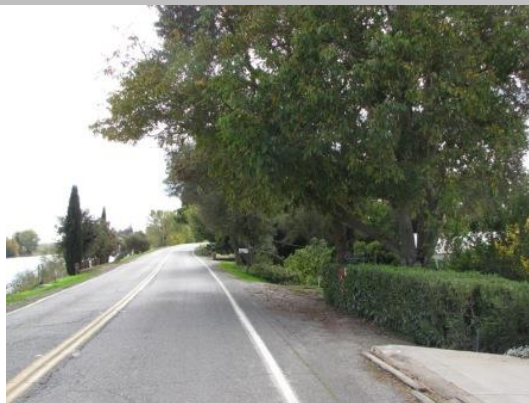
Photo 1 of 1 : SP\_2016\_RD0150\_16\_65\_20160219\_00035.jpg

LM Start	6.39	Rating **	M	Issue No.	65
LM End	6.46	Issue Type +	En	Location *	LS
Category	Earthen Levee			GPS Latitude/Longitude	
				Start	End
Item	Vegetation			38.394935 °	38.395931 °
				-121.514597 °	-121.514604 °
DWR ID	DWR_RD0150_02_s_2012_65				
Comment Code					
V6 : Landscaping					
Inspector Comment

View of landscaping along the waterward shoulder and slope looking downstream.

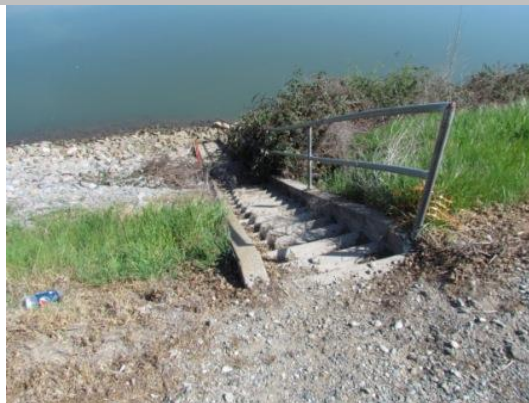
Photo 1 of 1 : SP\_2016\_RD0150\_16\_38\_20160219\_00021.jpg

LM Start	6.72	Rating **	M	Issue No.	38
LM End	6.72	Issue Type +	En	Location *	WS
Category	Earthen Levee			GPS Latitude/Longitude	
				Start	End
Item	Encroachments			38.399623 °	38.399623 °
				-121.514877 °	-121.514877 °
DWR ID	DWR_RD0150_02_s_2013_38				
Comment Code					
ST : Stairway					
Inspector Comment

A stairway was found on the waterside slope of the levee looking upstream during spring 2013 inspection.

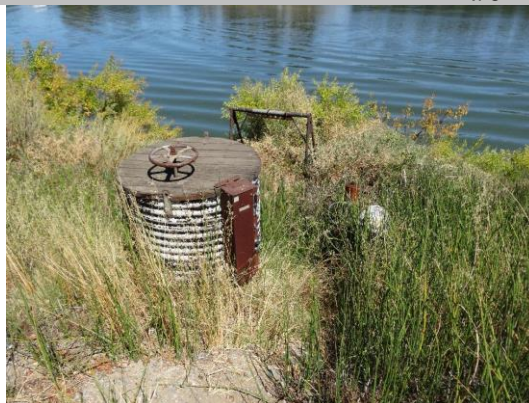
Photo 1 of 2 : UCIP\_SP\_2016\_20203\_34162.jpg

WS view: CMP riser with slide gate and pump (right) on levee slope.

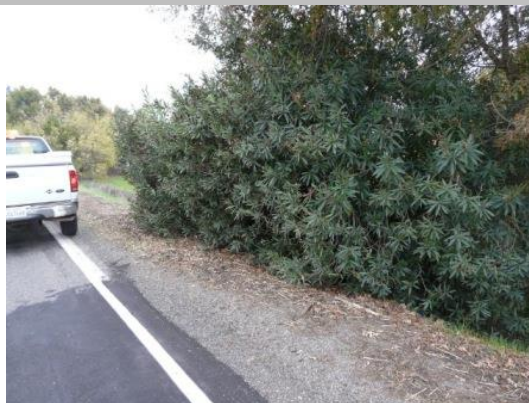
Photo 1 of 1 : SP\_2016\_RD0150\_16\_58\_20160219\_00032.jpg

LM Start	7.01	Rating **	M	Issue No.	58
LM End	7.01	Issue Type +	En	Location *	LS
Category	Earthen Levee			GPS Latitude/Longitude	
				Start	End
Item	Vegetation			38.403631 °	38.403631 °
				-121.516299 °	-121.516299 °
DWR ID	DWR_RD0150_02_s _ 2012_58				
Comment Code					
V6 : Landscaping					
Inspector Comment

Landscaping providing a screen for a residence on landside of levee at  
LM 7.12

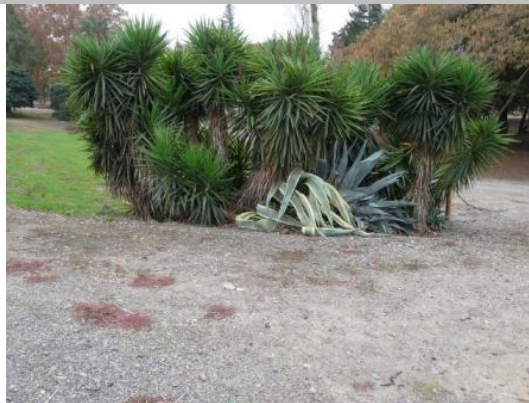
Photo 1 of 1 : SP\_2016\_RD0150\_16\_56\_20160219\_00031.jpg

LM Start	7.79	Rating **	M	Issue No.	56
LM End	7.79	Issue Type +	En	Location *	LS
Category	Earthen Levee			GPS Latitude/Longitude	
				Start	End
Item	Vegetation			38.413705 °	38.413705 °
				-121.522806 °	-121.522806 °
DWR ID	DWR_RD0150_02_s_2012_56				
Comment Code					
V6 : Landscaping					
Inspector Comment

Landscaping on landside of levee at LM 7.92

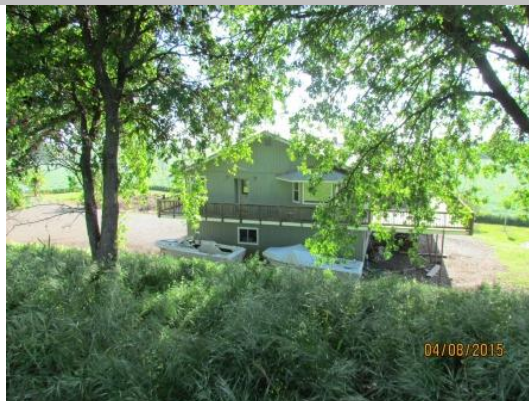
Photo 1 of 2 : SP\_2016\_RD0150\_17\_3\_20160219\_00001.jpg

View of a house on the landside toe of the levee looking upstream.

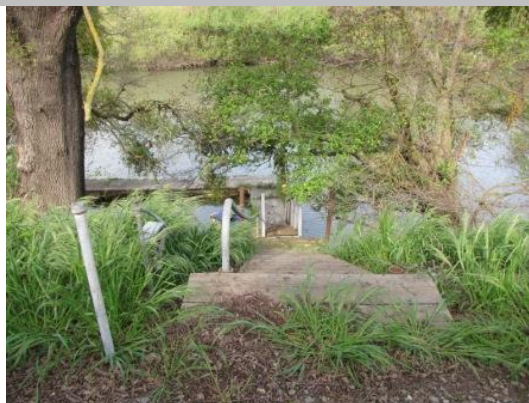
Photo 2 of 2 : SP\_2016\_RD0150\_17\_3\_20160219\_00002.jpg

View of steps, a dock, and associated utilities on the waterward slope.

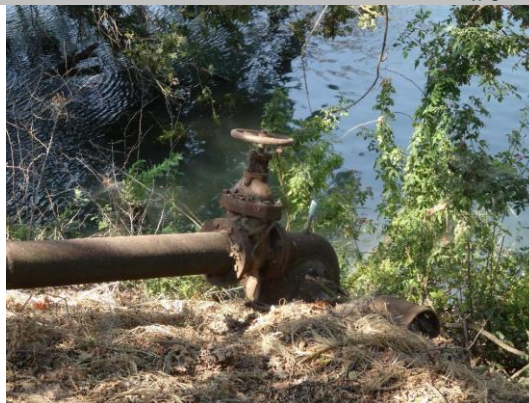
Photo 1 of 2 : UCIP\_SP\_2016\_42694\_32005.jpg

LM Start	0.39	Rating **	M	Issue No.	964
LM End	0.39	Issue Type +	En	Location *	WS
Category	Supplemental			GPS Latitude/Longitude	
				Start	End
Item	DWR UCIP Field Study			38.337928 °	38.337928 °
				-121.581496 °	-121.581496 °
DWR ID					
Comment Code					
Inspector Comment					
FS_ID:42694 DS_ID:22453 EP_NO: 13612 Repair Type: Non-Urgent Crossing Status: Found UCIP Comments: Abandoned. Proper abandone needs. FIELD_STRUCT_DESC: Abandoned 6-inch steel pipe through the levee, 3.5 feet below the crown. Pump and gate valve on the waterward slope. FS Date: 8/20/2013

WS view: pipe and pump on levee slope.

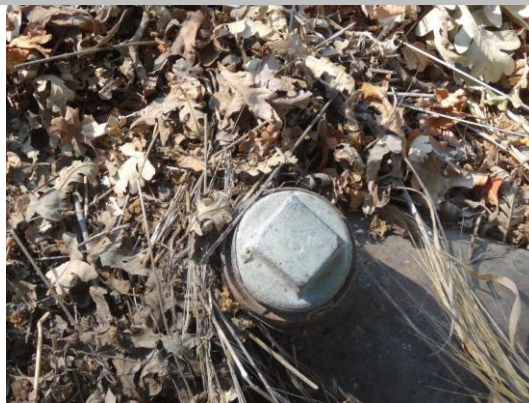
Photo 2 of 2 : UCIP\_SP\_2016\_42694\_32004.jpg

LM Start	<b>0.39</b>	Rating **	M	Issue No.	<b>964 (cont)</b>
LM End	<b>0.39</b>	Issue Type +	En	Location *	WS

WS view: safety valve on steel pipe.

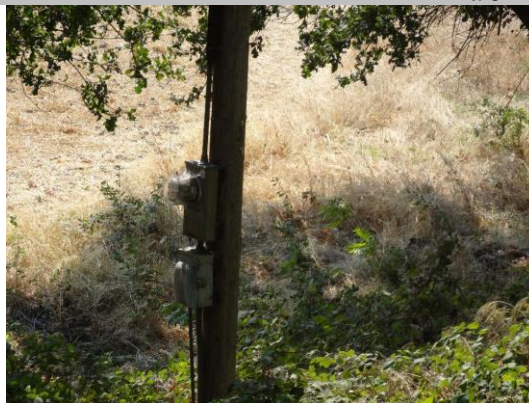
Photo 1 of 2 : UCIP\_SP\_2016\_42693\_31979.jpg

LM Start	0.40	Rating **	M	Issue No.	963
LM End	0.40	Issue Type +	En	Location *	WS
Category	Supplemental			GPS Latitude/Longitude	
				Start	End
Item	DWR UCIP Field Study			38.338131 °	38.338131 °
				-121.581434 °	-121.581434 °
DWR ID					
Comment Code					
Inspector Comment					
FS_ID:42693 DS_ID:22454 EP_NO: N/A Repair Type: Non-Urgent Crossing Status: Found UCIP Comments: Seems to be abandoned. Service pole on LS slope.  1" conduit through levee.May need proper abandonment. FIELD_STRUCT_DESC: 6-inch steel pipe through the levee, 3.5 feet below the crown. Pump and gate valve on the waterward slope. FS Date: 8/20/2013

LS view: service pole on levee slope.

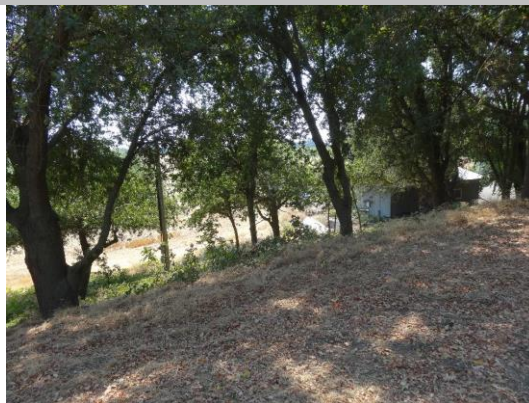
Photo 2 of 2 : UCIP\_SP\_2016\_42693\_31978.jpg

LM Start	<b>0.40</b>	Rating **	M	Issue No.	<b>963 (cont)</b>
LM End	<b>0.40</b>	Issue Type +	En	Location *	WS

LS view: no pipe on levee slope.

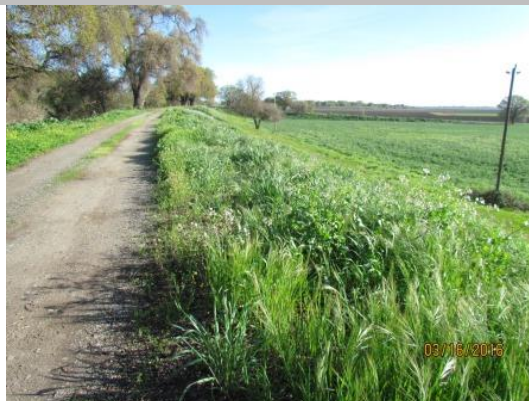
Photo 1 of 1 : SP\_2016\_RD0150\_17\_76\_20160321\_00142.jpg

View of the vegetation on the landside of the levee.

LM Start	0.41	Rating **	M	Issue No.	76
LM End	2.33	Issue Type +	Ma	Location *	LS
Category	Earthen Levee			GPS Latitude/Longitude	
				Start	End
Item	Vegetation			38.338311 °	38.354484 °
				-121.581394 °	-121.564198 °
DWR ID	DWR_RD0150_03_s_2016_76				
Comment Code					
V1 : Control annual grass and weeds on the levee slopes and easements.					
Inspector Comment

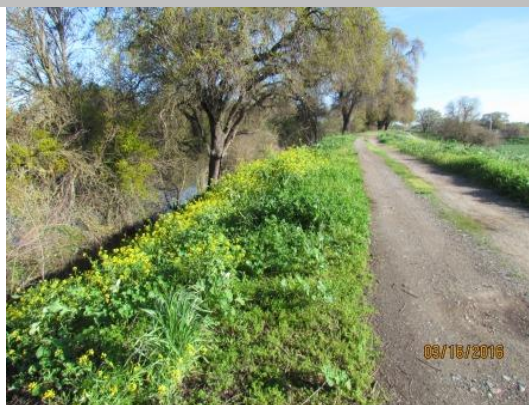
Photo 1 of 1 : SP\_2016\_RD0150\_17\_74\_20160321\_00143.jpg

View of the vegetation on the waterside of the levee.

LM Start	0.41	Rating **	M	Issue No.	74
LM End	2.33	Issue Type +	Ma	Location *	WS
Category	Earthen Levee			GPS Latitude/Longitude	
				Start	End
Item	Vegetation			38.338311 °	38.354485 °
				-121.581394 °	-121.564199 °
DWR ID	DWR_RD0150_03_s_2016_74				
Comment Code					
V1 : Control annual grass and weeds on the levee slopes and easements.					
Inspector Comment

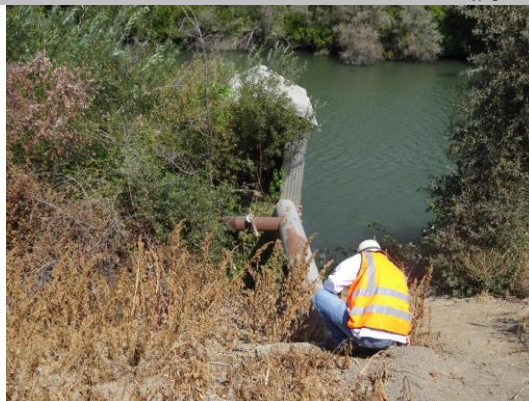
Photo 1 of 2 : UCIP\_SP\_2016\_19112\_32044.jpg

FS\_ID:19112  
DS\_ID:22433  
EP\_NO: N/A  
Repair Type: Non-Urgent  
Crossing Status: Found  
UCIP Comments: No handrail on wooden walkway.  
FIELD\_STRUCT\_DESC: 14-inch steel pipe through the levee, 8.0 feet below the crown, pump in pump house on the waterward slope. Service pole and steel distribution box on the landward slope.  
FS Date: 8/20/2013

WS view: pipe on levee slope and pump house in channel.

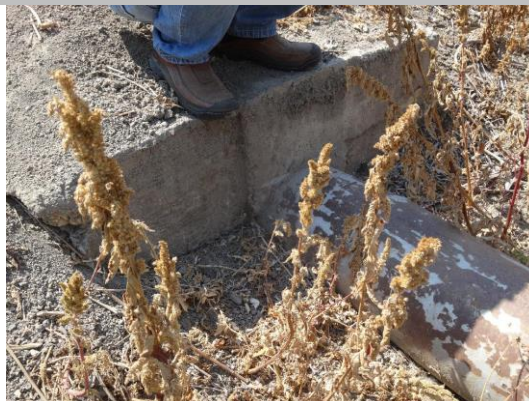
Photo 2 of 2 : UCIP\_SP\_2016\_19112\_32043.jpg

WS view: concrete headwall and exposed pipe on levee slope.

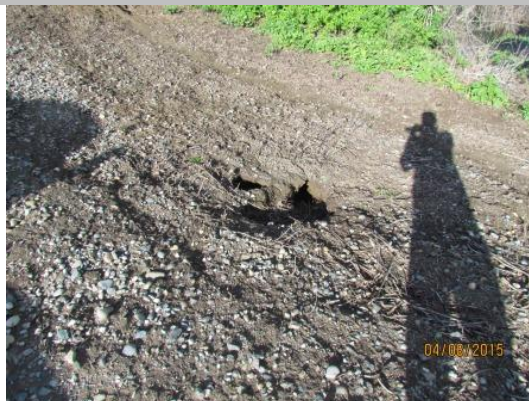
Photo 1 of 1 : SP\_2016\_RD0150\_17\_393\_20160219\_00091.jpg

Rodent holes were found on the waterside of the levee looking downstream.

LM Start	1.40	Rating **	M	Issue No.	393
LM End	1.40	Issue Type +	Ma	Location *	WS
Category	Earthen Levee			GPS Latitude/Longitude	
				Start	End
Item	Animal Control			38.347880 °	38.347880 °
				-121.572500 °	-121.572500 °
DWR ID	DWR_RD0150_03_s_2015_393				
Comment Code					
A3 : No rodents visible, but rodent burrows visible; need to backfill and compact or grout burrows.					
Inspector Comment

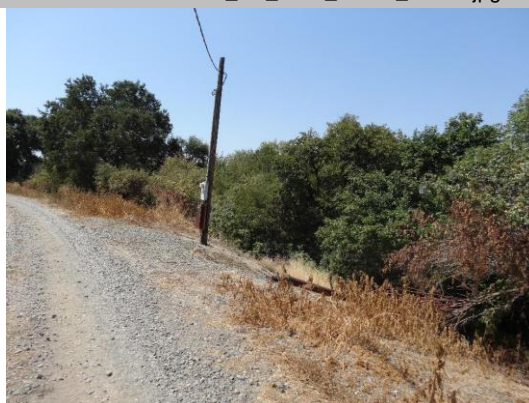
Photo 1 of 2 : UCIP\_SP\_2016\_19137\_32108.jpg

LM Start	1.78	Rating **	M	Issue No.	951
LM End	1.78	Issue Type +	En	Location *	WS
Category	Supplemental			GPS Latitude/Longitude	
				Start	End
Item	DWR UCIP Field Study			38.353180 °	38.353180 °
				-121.572907 °	-121.572907 °
DWR ID					
Comment Code					
Inspector Comment					
FS_ID:19137 DS_ID:22434 EP_NO: N/A Repair Type: Non-Urgent Crossing Status: Found UCIP Comments: Small depression on WS slope due to leak from pump. Pipe opens on LS ditch/depression. FIELD_STRUCT_DESC: 10-inch pipe through the levee, 3.4 feet below the crown, pump, gate valve and service pole on the waterward slope. FS Date: 8/20/2013

WS view: exposed pipe and power pole on levee slope.

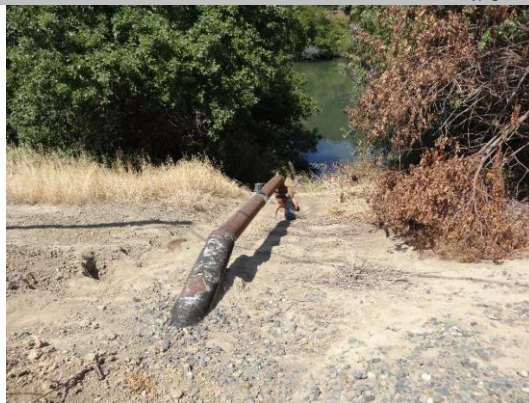
Photo 2 of 2 : UCIP\_SP\_2016\_19137\_32107.jpg

LM Start	1.78	Rating **	M	Issue No.	951 (cont)
LM End	1.78	Issue Type +	En	Location *	WS
Category	Supplemental			GPS Latitude/Longitude	
				Start	End
Item	DWR UCIP Field Study			38.353180 °	38.353180 °
				-121.572907 °	-121.572907 °
DWR ID					
Comment Code					
Inspector Comment					
FS_ID:19137 DS_ID:22434 EP_NO: N/A Repair Type: Non-Urgent Crossing Status: Found UCIP Comments: Small depression on WS slope due to leak from pump. Pipe opens on LS ditch/depression. FIELD_STRUCT_DESC: 10-inch pipe through the levee, 3.4 feet below the crown, pump, gate valve and service pole on the waterward slope. FS Date: 8/20/2013

WS view: exposed pipe on levee slope.

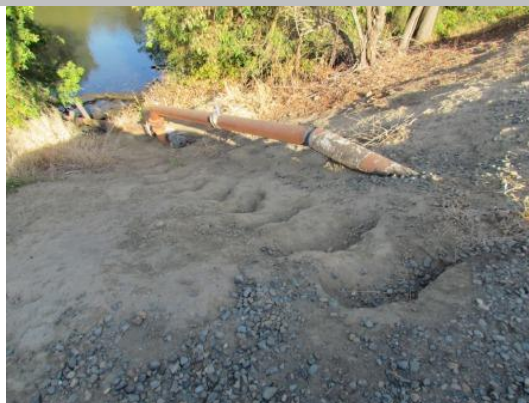
Photo 1 of 1 : SP\_2016\_RD0150\_17\_50\_20160219\_00043.jpg

Steps were dug next to the pipe and also erosion was found near the vicinity of the pipe on the waterside slope of the levee looking upstream.

LM Start	1.78	Rating **	M	Issue No.	50
LM End	1.78	Issue Type +	Ma	Location *	WS
Category	Earthen Levee			GPS Latitude/Longitude	
				Start	End
Item	Erosion / Bank Caving			38.353249 °	38.353249 °
				-121.572848 °	-121.572848 °
DWR ID	DWR_RD0150_03_s_2012_50				
Comment Code					
E1 : Note and monitor erosion site.					
Inspector Comment					
Erosion appeared under the pipe.

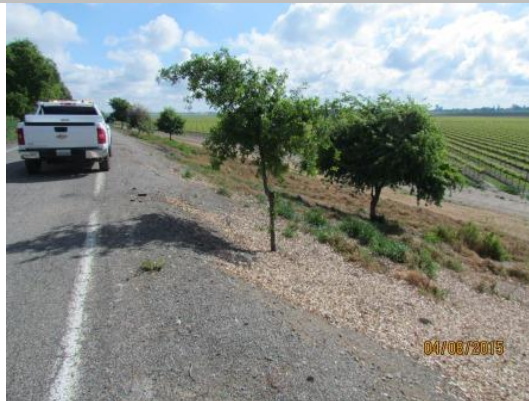
Photo 1 of 4 : SP\_2016\_RD0150\_17\_78\_20160219\_00071.jpg

LM Start	<b>2.31</b>	Rating **	M	Issue No.	<b>78 (cont)</b>
LM End	<b>2.31</b>	Issue Type +	Ma	Location *	LS

Updated picture of the trees on the landside of the levee during spring 2015 inspection.

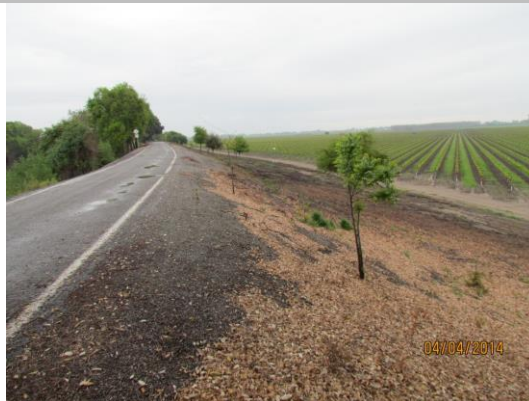
Photo 2 of 4 : SP\_2016\_RD0150\_17\_78\_20160219\_00072.jpg

View of the newly planted tree on the landside slope of the levee during spring 2014 inspection.

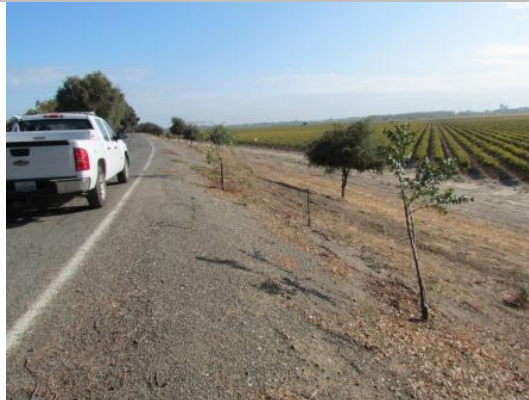
Photo 3 of 4 : SP\_2016\_RD0150\_17\_78\_20160219\_00073.jpg

Several newly planted trees were found on the landside slope of the levee looking upstream during the fall 2013 inspection.

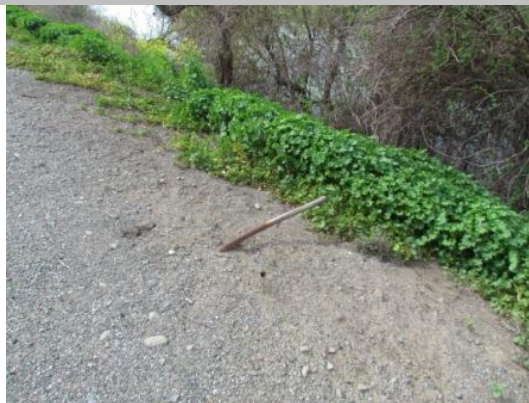
Photo 1 of 1 : SP\_2016\_RD0150\_17\_34\_20160219\_00027.jpg

LM Start	2.66	Rating **	M	Issue No.	34
LM End	2.66	Issue Type +	En	Location *	WS
Category	Earthen Levee			GPS Latitude/Longitude	
				Start	End
Item	Encroachments			38.358406 °	38.358406 °
				-121.561300 °	-121.561300 °
DWR ID	DWR_RD0150_03_s_2013_34				
Comment Code					
PI : Pipe					
Inspector Comment

A pipe was found on the waterside shoulder of the levee looking downstream during spring 2013 inspection.

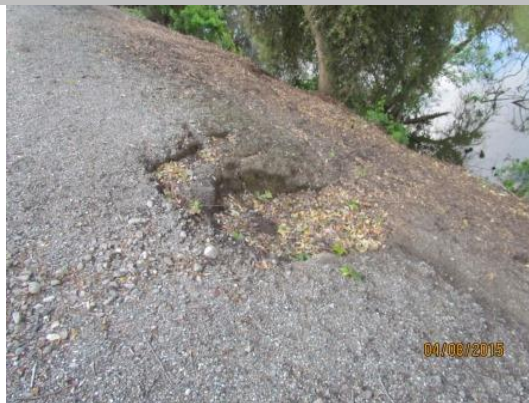
Photo 1 of 2 : SP\_2016\_RD0150\_17\_35\_20160219\_00028.jpg

Updated picture of the erosion on the waterside of the levee during spring 2015 inspection.

LM Start	2.80	Rating **	M	Issue No.	35
LM End	2.80	Issue Type +	Ma	Location *	WS
Category	Earthen Levee			GPS Latitude/Longitude	
				Start	End
Item	Erosion / Bank Caving			38.360432 °	38.360432 °
				-121.561644 °	-121.561644 °
DWR ID	DWR_RD0150_03_s_2013_35				
Comment Code					
E2 : Schedule repair of erosion site prior to the next inspection.					
Inspector Comment

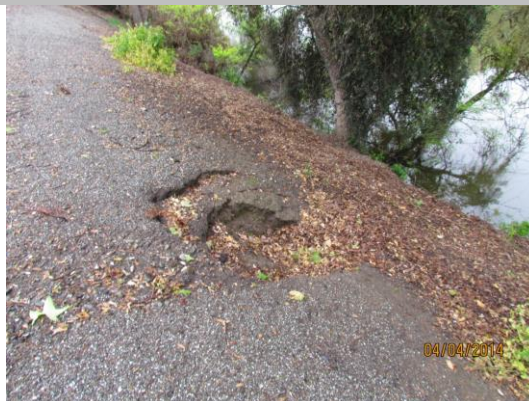
Photo 2 of 2 : SP\_2016\_RD0150\_17\_35\_20160219\_00029.jpg

Updated picture of the erosion on the waterside slope of the levee during spring 2014 inspection.

LM Start	2.80	Rating **	M	Issue No.	35 (cont)	
LM End	2.80	Issue Type +	Ma	Location *	WS	
Category	Earthen Levee			GPS Latitude/Longitude		
				Start		End
Item	Erosion / Bank Caving			38.360432 °		38.360432 °
				-121.561644 °		-121.561644 °
DWR ID	DWR_RD0150_03_s _ 2013_35					
Comment Code						
E2 : Schedule repair of erosion site prior to the next inspection.						
Inspector Comment

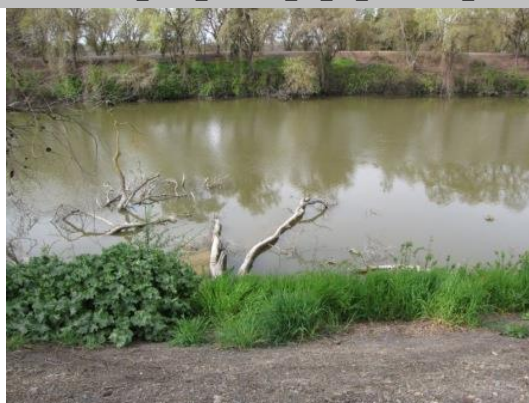
Photo 1 of 1 : SP\_2016\_RD0150\_17\_17\_20160219\_00015.jpg

LM Start	2.82	Rating **	N	Issue No.	17
LM End	2.82	Issue Type +	Ma	Location *	WS
Category	Earthen Levee			GPS Latitude/Longitude	
				Start	End
Item	Trim / Thin Trees			38.360621 °	38.360621 °
				-121.561762 °	-121.561762 °
DWR ID	DWR_RD0150_03_s _2012_17				
Comment Code					
T5 : Tree stumps.					
Inspector Comment

View of tree stumps on the waterward slope.

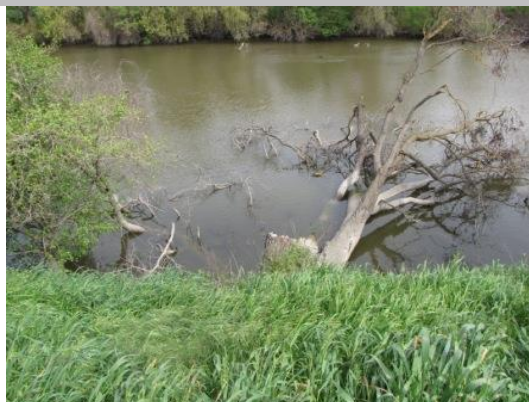
Photo 1 of 1 : SP\_2016\_RD0150\_17\_20\_20160219\_00016.jpg

LM Start	3.15	Rating **	N	Issue No.	20
LM End	3.15	Issue Type +	Ma	Location *	WS
Category	Earthen Levee			GPS Latitude/Longitude	
				Start	End
Item	Trim / Thin Trees			38.363658 °	38.363658 °
				-121.559583 °	-121.559583 °
DWR ID	DWR_RD0150_03_s _ 2012_20				
Comment Code					
T5 : Tree stumps.					
Inspector Comment

View of tree stumps on the waterward slope.

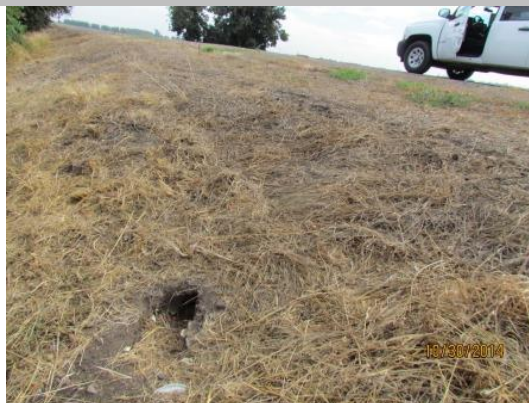
Photo 1 of 1 : SP\_2016\_RD0150\_17\_77\_20160219\_00070.jpg

A rodent hole was found on the waterside of the levee looking upstream.

LM Start	3.20	Rating **	M	Issue No.	77
LM End	3.20	Issue Type +	Ma	Location *	WS
Category	Earthen Levee			GPS Latitude/Longitude	
				Start	End
Item	Animal Control			38.363364 °	38.363364 °
				-121.558682 °	-121.558682 °
DWR ID	DWR_RD0150_03_f_2014_77				
Comment Code					
A3 : No rodents visible, but rodent burrows visible; need to backfill and compact or grout burrows.					
Inspector Comment
